The Pencil (is Mightier Than The Sword) [composite view]

Last Condition Report: 6/26/14

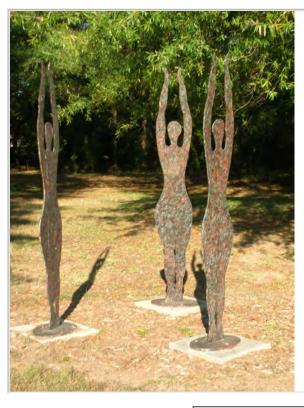
Tadasana (Mountain Pose)

2 of 3 statues need bolts tightened

3/30/2011 - Permanent Collection cmt. recs clean / fix. Will submit report & req. at April CHPAC mtg. Clean off bird droppings, etc.

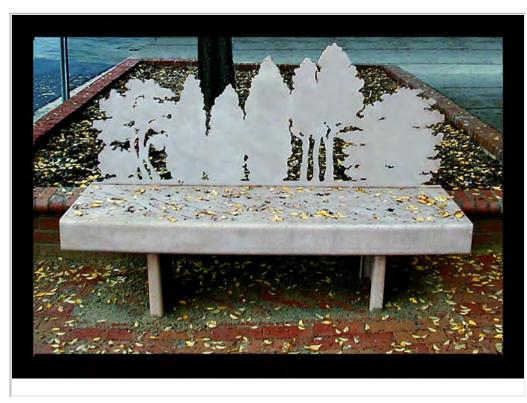
Title: *Treescapes*

Covered w/ dirt, gum, stickers, scratches. Condition:

3/30/2011 - Permanent Collection cmt. recs clean / fix. Will submit report & req. at April CHPAC mtg. Clean off stickers, powerwash. "The benches should be cleaned occasionally with a steam jenny to remove food stain." see "CHAPEL HILL- MAINTENANCE PLAN.doc"

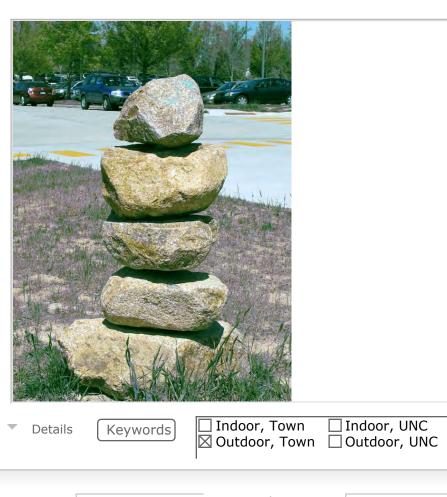
Elemental Landscape: Cairn at Park & Ride Lot

Top rock can be rotated and lifted slightly (2"), but not pulled off. Condition:

Maintenance / Treatment Rec.: re-epoxy bottom of rock to pole

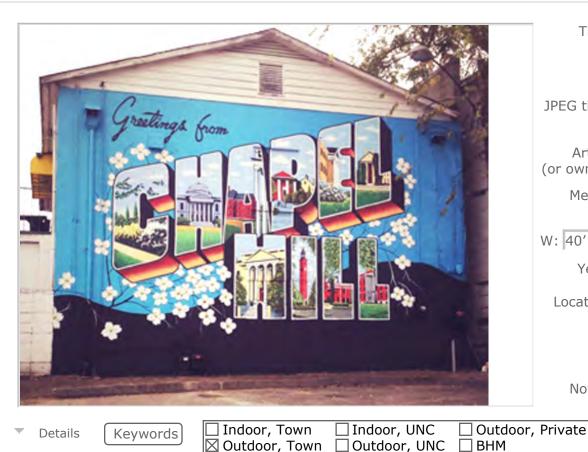
1941 Curt Teich Postcard

small piece of graffiti lower right corner; paint/surface peeling upper Condition: right corner.

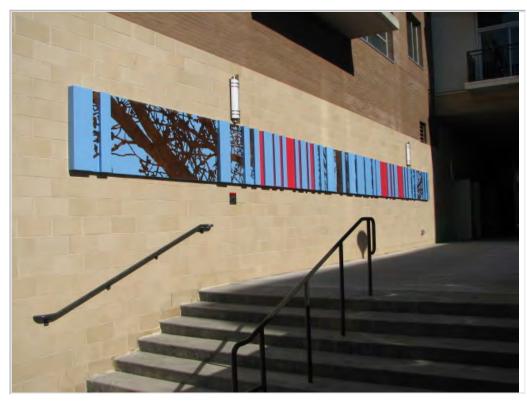
Tarheel Blues

20-30 small rust spots on face, a few small chucks of paint also lost. Rusty water stain on under seams. Lights partially installed on wall above piece. JY will contact GH re: spots.

wash every 6 months w/ mix of 1 gallon water + 1 cup neutral detergent & wipe with rag. Do not spray. Do not wash when temp is above 75 degrees F. See contract Exhibit B Materials and Installation Specifications document

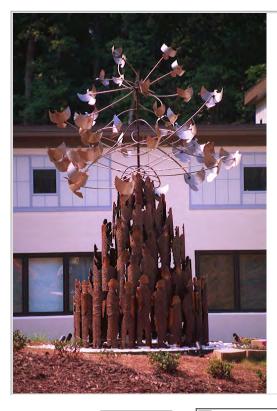
Promethean Honor Guard

Fine. Spins in wind, some bird droppings, could use a coat of oil. - JY

3/30/2011 - Permanent Collection cmt. recs clean / fix. Will submit report & req. at April CHPAC mtg. Polish & lube entire piece - overdue for oil according to instructions. Stainless arms holding birds are dirty, stone bed needs weeding, remove debris from inner circle.

Needs to be oiled once per year.

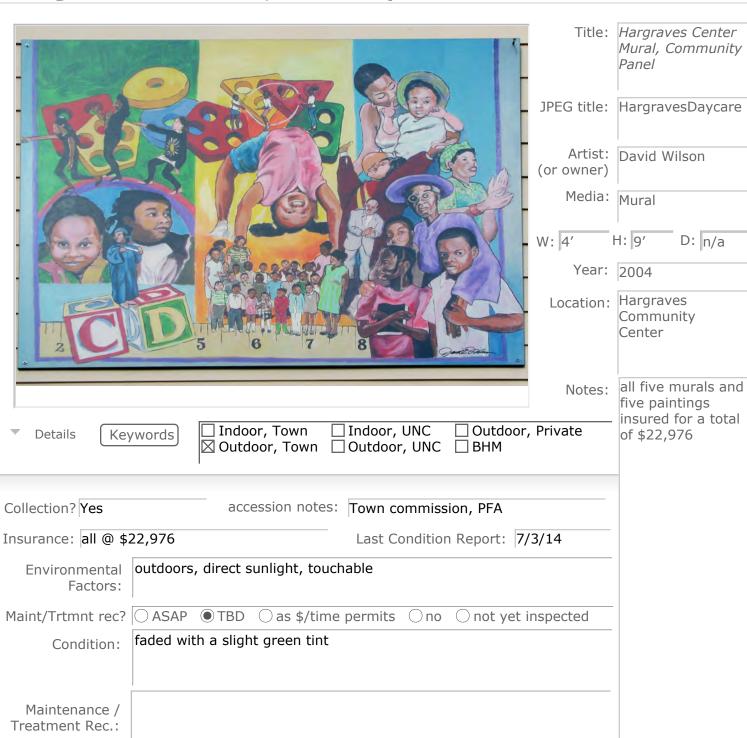
Hargraves Center Mural, Community Panel

screw in upper right corner coming out (SBW). 2/26/2010 - repair

req. to John Newark (Facilities), fixed soon after

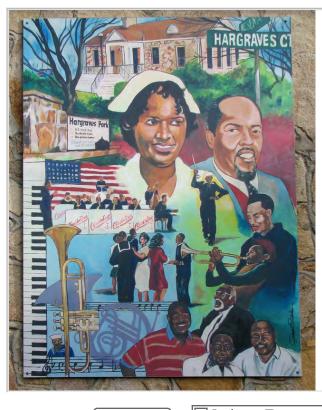
Hargraves Center Mural, History Panel I

faded with a slight green tint Condition:

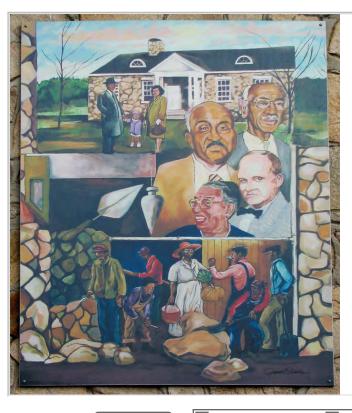
Hargraves Center Mural, History Panel II

faded with a slight green tint. Upper rt. corner a bit nicked from washer?

upper rt. corner screw had come loose from wall and corner of panel detached from wall, noticed & req. to PW sent 9/26/2011. PW never fixed, 2/24/2012 J. Greene fixed.

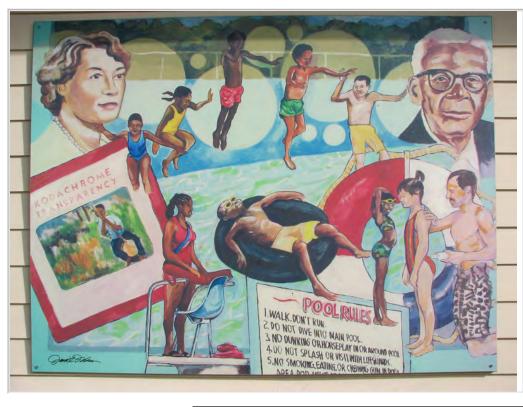
Hargraves Center Mural, Pool Panel

faded with a slight green tint. a few drops of exterior wall paint have fallen on mural.

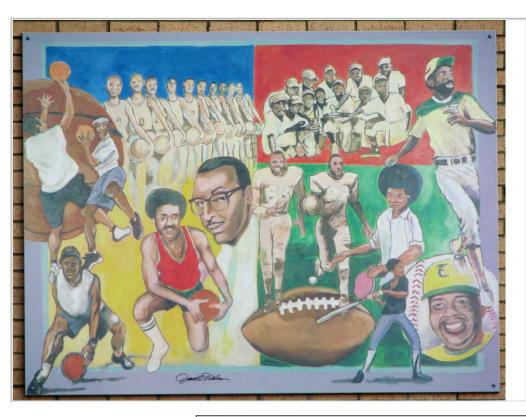
Hargraves Center Mural, Sports Panel

faded with a slight green tint Condition:

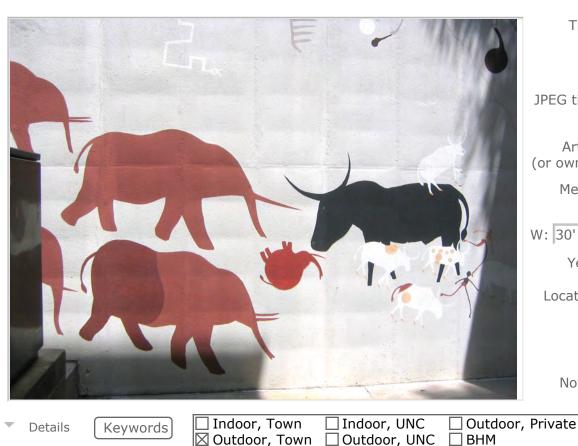
Title: *Primitive (Cave)* Paintings (IVI 1, north wall, mid #1)

cracks, stains Condition:

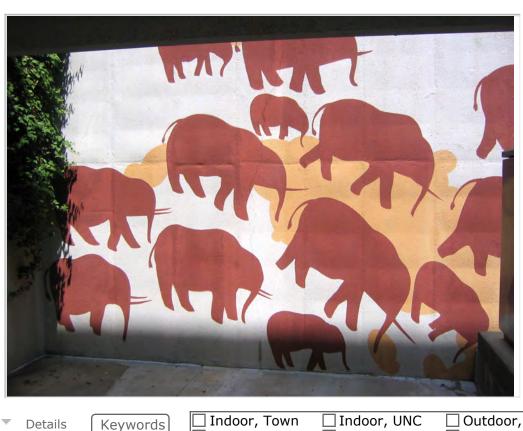
Primitive (Cave) Paintings (Ivl 1, north wall, mid #2)

cracks, stain, leftover ivy debris Condition:

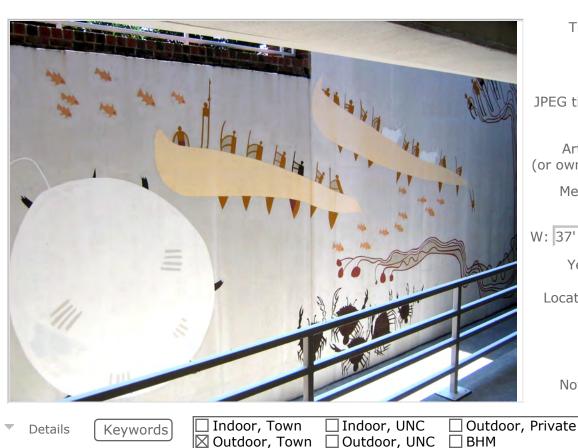
Primitive (Cave) Paintings (IvI 2, east wall, crabs)

crack in seam, water stains Condition:

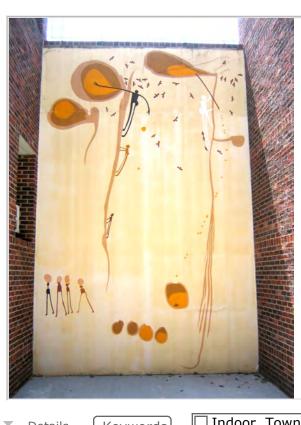
Primitive (Cave) Paintings (IvI 2, south wall, mid west)

now a fenced-in storage area with items blocking wall. Cracks, water

staining at top

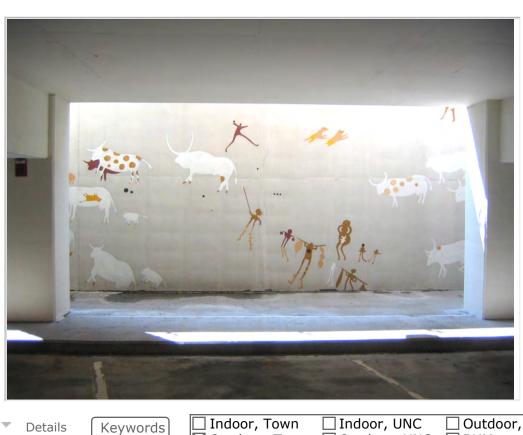
Primitive (Cave) Paintings (Ivl 2, south wall, west #1)

cracks, damaged cememt floor at corner, scrapes on mural Condition:

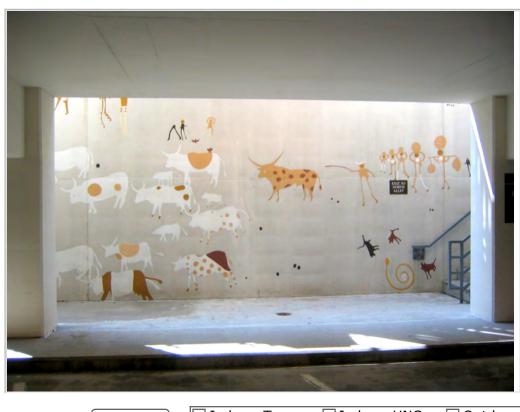
Primitive (Cave) Paintings (Ivl 2, south wall, west #2)

cracks, water stains from railings

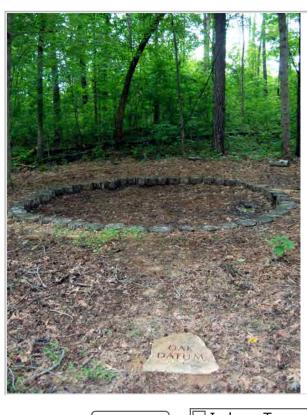
Elemental Landscape: Datum, Oak

Stone marker now visible. Logs quite deteriorated; what to do (create new interior log ring) TBD

2/17/12 - filling with leaves, stumps beginning to decay, couldn't locate stone marker (covered w/ leaves, earth?) - SBW 2/17/12

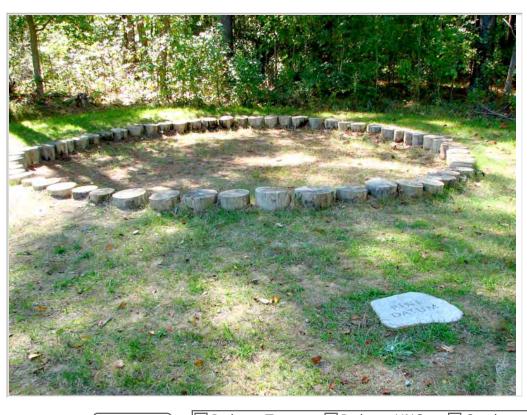
Elemental Landscape: Datum, Pine

Logs quite deteriorated; what to do (create new interior log ring) TBD

2/17/2012 - appx. 5-7 stumps rotting, deteriorated, but this is concept of piece. Eventually a new ring should be established inside of the deteriorated ring.

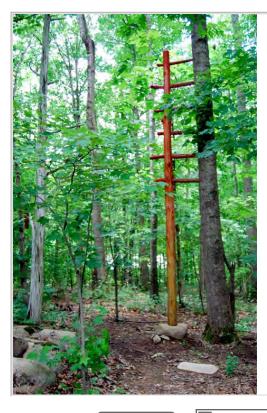
Elemental Landscape: Fire

faded, repaired rung gone.

2/17/2012 - one end rung found on ground; screw broke.

2/20/2012 - J. Greene refastened rung end w/ 2 screws, filled screw holes w/ epoxy to slow rusting of screws.
