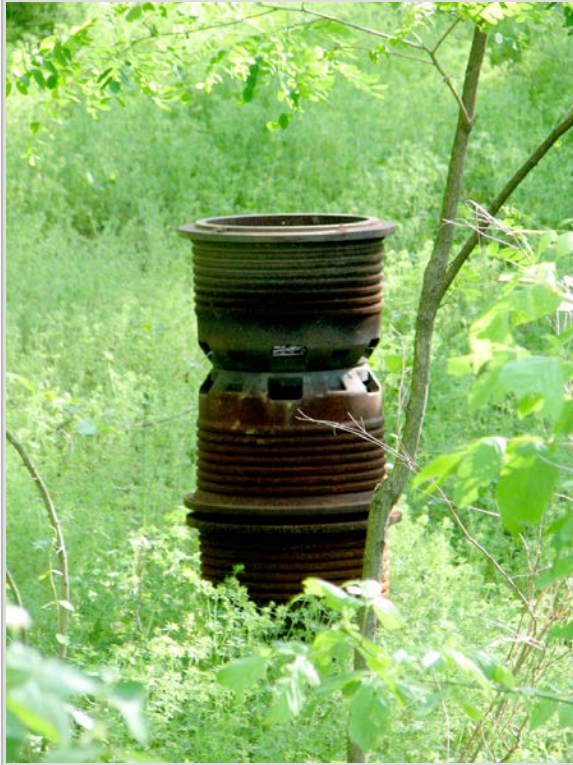
Greenways Trails Prototypes: Sentry, short (MLK plaza)

Condition: Good

Maintenance / Treatment Rec.: None needed: "This work is expected to weather naturally and is composed of materials that should easily last 50+ years." See Final Report document.

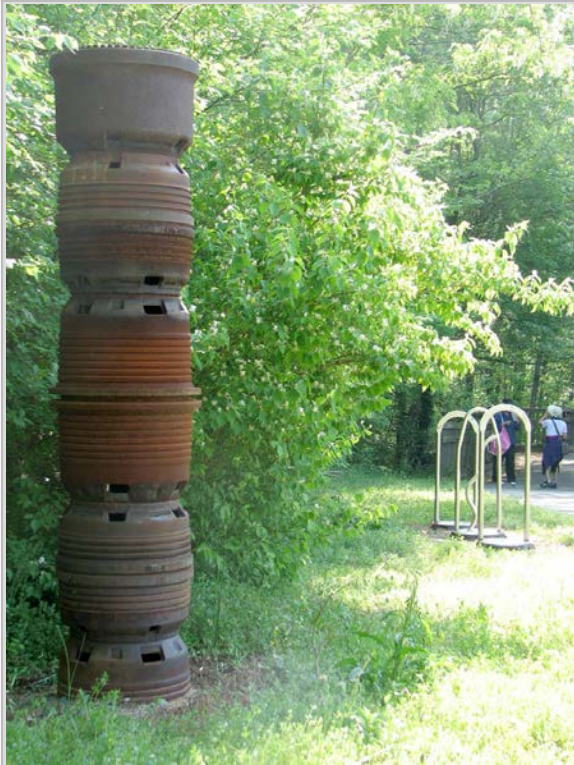
Greenways Trails Prototypes: Sentry, tall@racks (MLK plaza)

Condition: Good.

Maintenance / Treatment Rec.: None needed: "This work is expected to weather naturally and is composed of materials that should easily last 50+ years." See Final Report document.

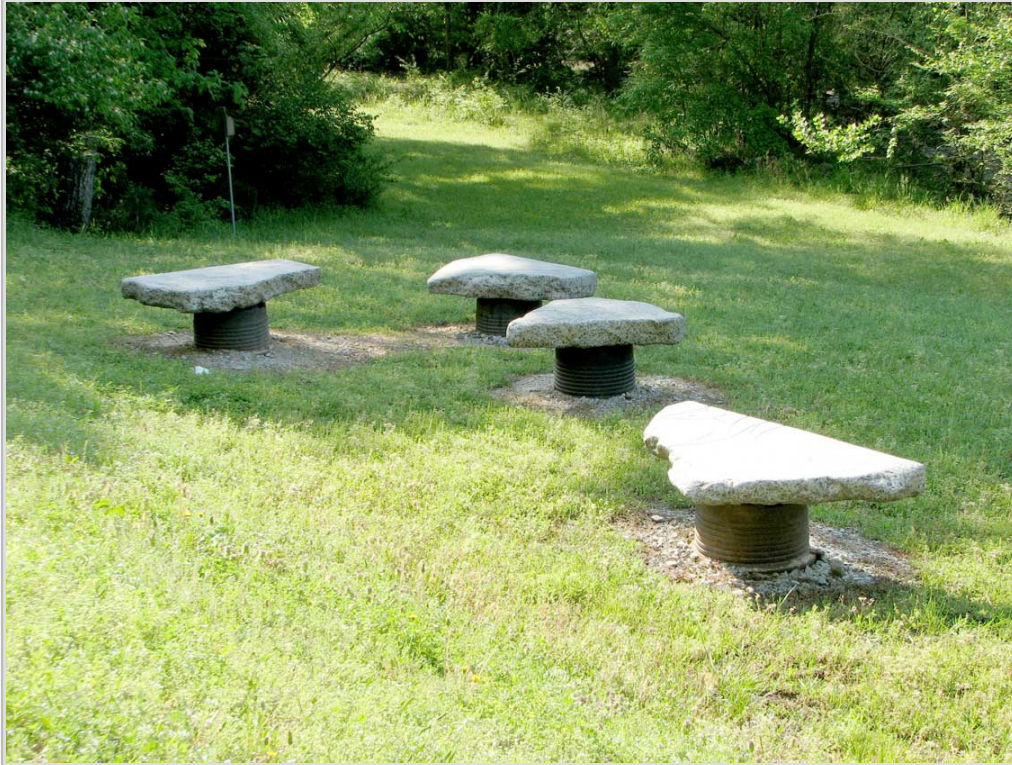
Greenways Trails Prototypes: Benches (MLK Plaza)

Condition: Good. Bench closest to road has hairline crack across its corner - surface level only.

Maintenance / Treatment Rec.: Only seating surfaces may require clearing, and "if necessary the concrete could be resealed with either Penetrol or concrete-sealer." See Final Report document

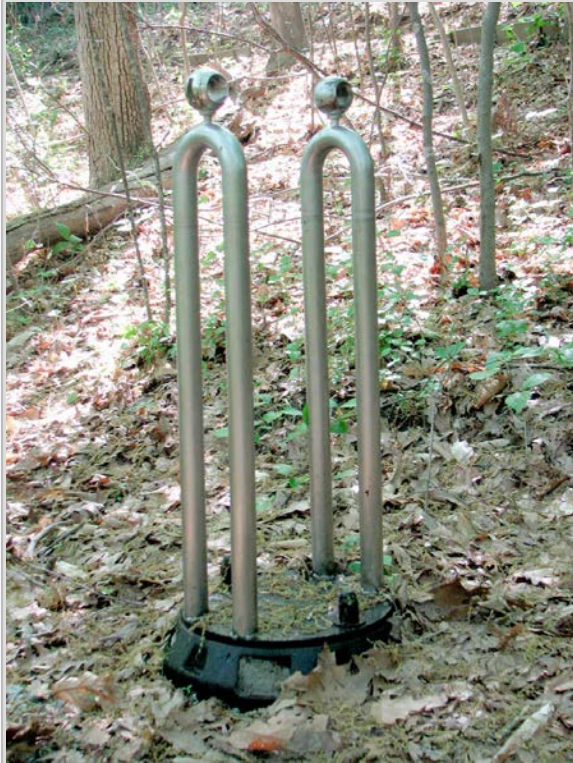
Greenways Trails Prototypes: Bike Racks (Cafe Driade)

Environmental Factors: in woods, near path, bike collisions

Condition: Good. Discoloration / flaw on one of the top bulbs

Maintenance / Treatment Rec.: None needed: "This work is expected to weather naturally and is composed of materials that should easily last 50+ years." See Final Report document.

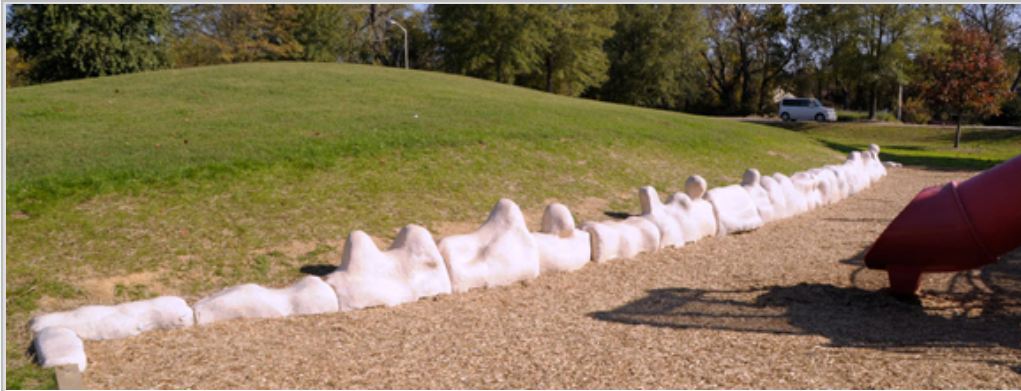
Sculptural Climbing Wall

Condition: good overall.

Earlier Reports: 2013 - grass regrown behind wall - big improvement
8/2012 - playground mulch replaced with foam surface w/o consulting Arts Office

Maintenance / Treatment Rec.: "Short-term - Recommend pressure wash/grinding and resealing if stained or graffiti. Long-term- see MATERIALS AND INSTALLATION SPECIFICATIONS DOCUMENT

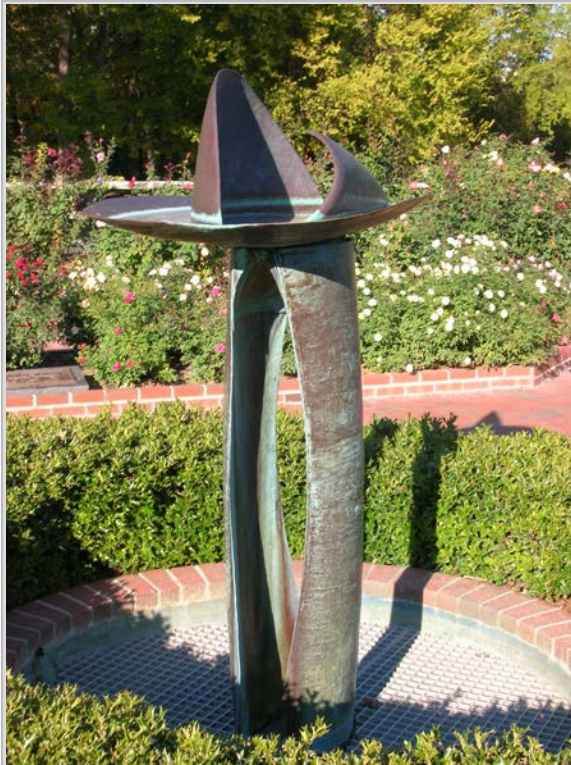
As The Heart Remembers Spring

Condition: good overall, though small areas of orange rust on lower interior edge

Maintenance / Treatment Rec.: Fountain "turned off" during winter. Now maintained by Mike Dickinson (919) 619-5102, contracted by Strowd Roses

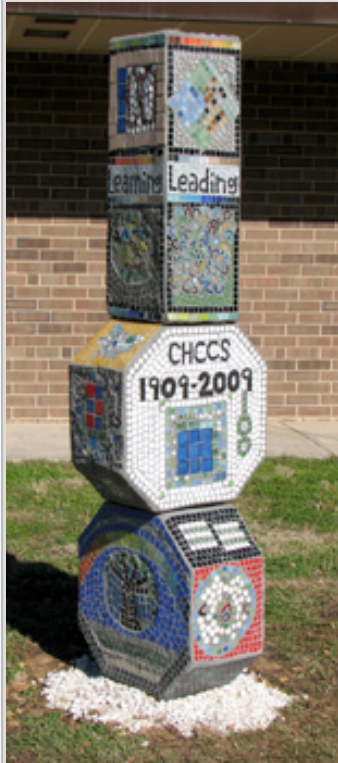
100 Mosaic Totem

Condition: Brossart contracted by office to repair cracks in cement, replace lost tiles, apply clearcoat Oct. of 2014.

Maintenance /
Treatment Rec.: Gently wash with water and wet rag. Use vinegar on white rag to polish mosaic pieces. See "100 care instructions.rtf"

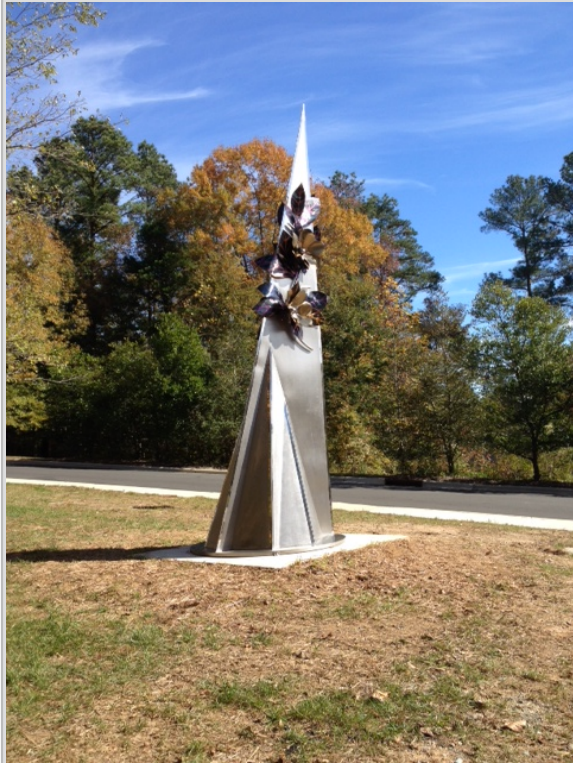
Magnolia Exotica

Condition: Good

Maintenance / Treatment Rec.: "General cleaning with a hose, water and a light non-ionic detergent as needed." See "Gifts Disclosure Form 12 02_final.doc"

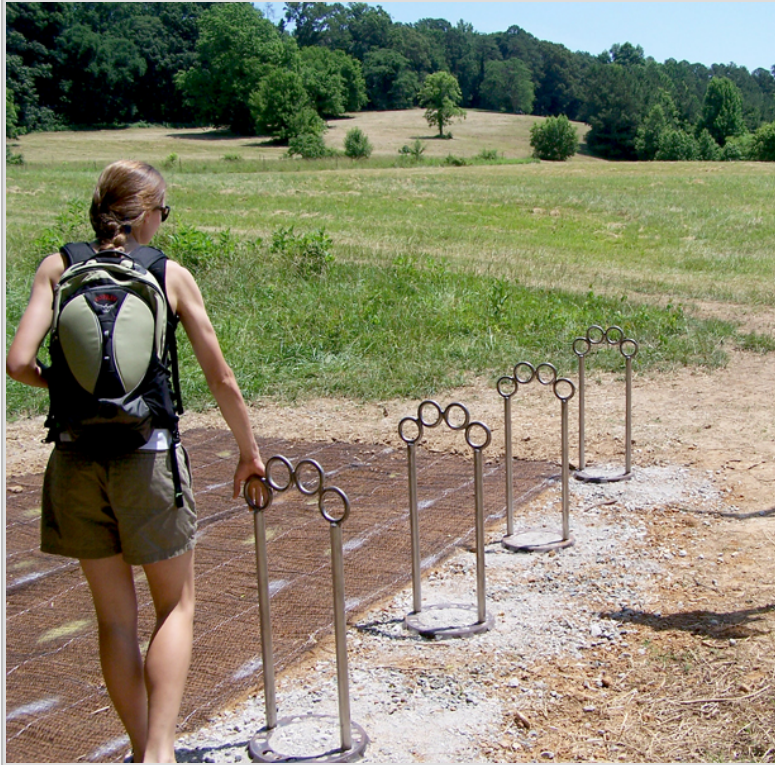
Bike Racks (Merritt's Pasture)

Condition: Good. Some abraded areas have a little rust and corrosion. Some bird droppings. -JY

Maintenance / Treatment Rec.: None needed: "This work is expected to weather naturally and is composed of materials that should easily last 50+ years." See Final Report document.

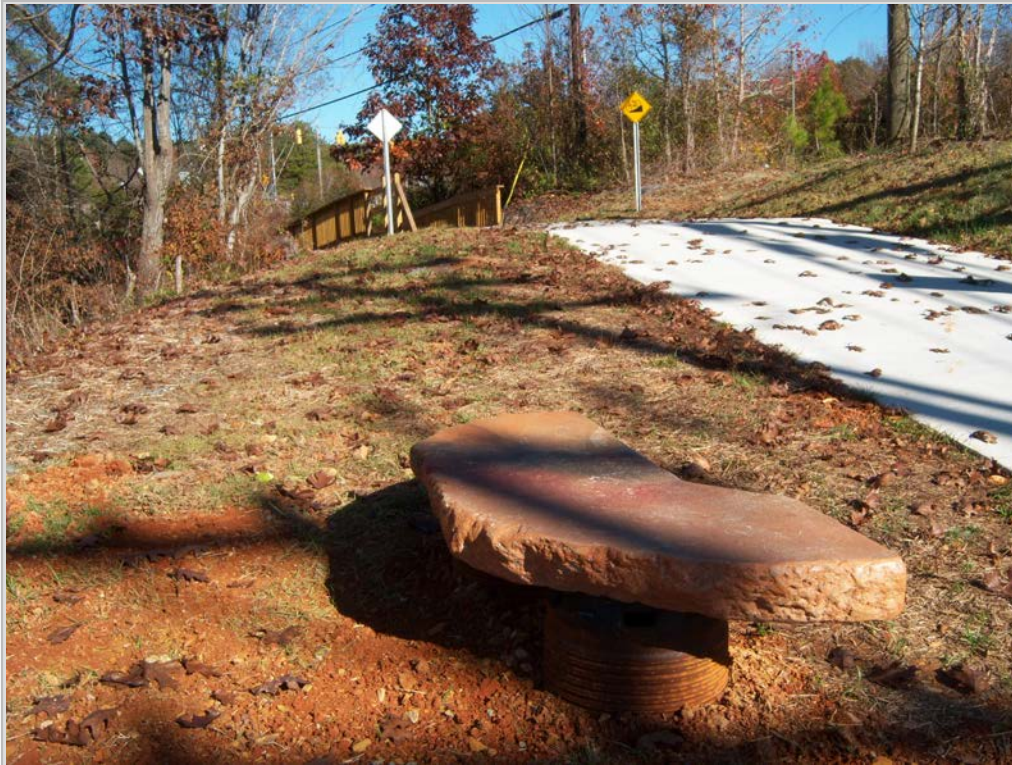
Bench (Morgan Creek)

Condition: Good. Clay dust on lower parts. - JY

Maintenance / Treatment Rec.: Only seating surfaces may require clearing, and "if necessary the concrete could be resealed with either Penetrol or concrete-sealer." See Final Report document

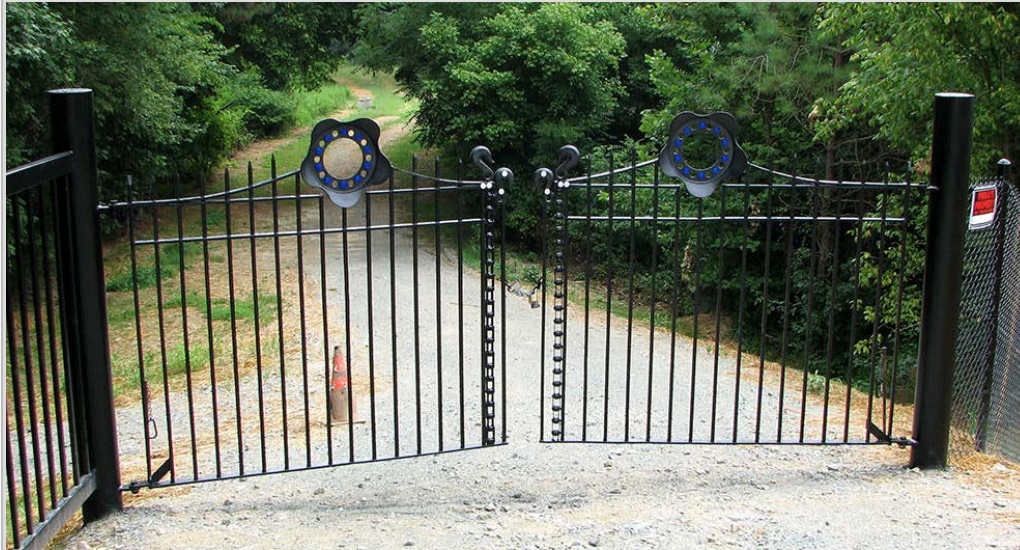
Culbreth Road Gate north side

Condition: Excellent

Maintenance / Treatment Rec.: is piece supposed to weather like other Frega pieces or should it be repainted occasionally?

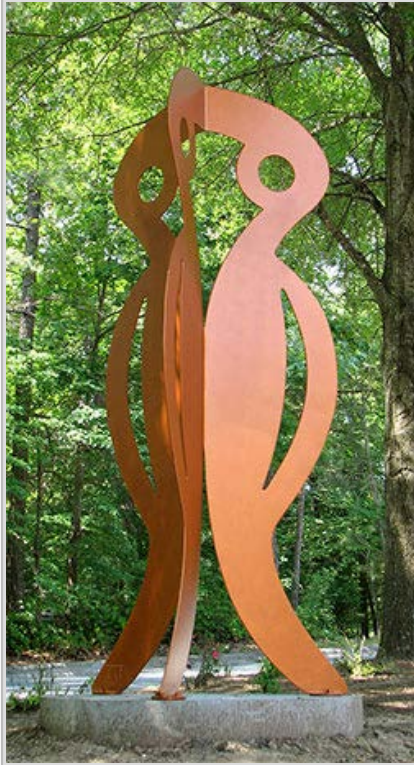
Three Birds

Condition: Excellent

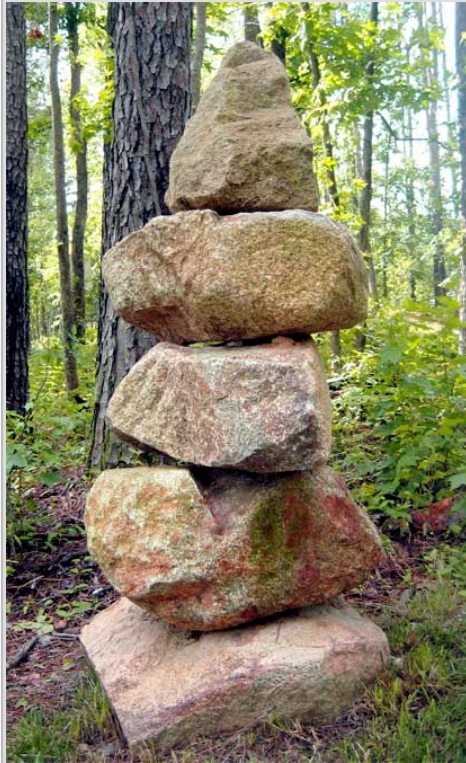
Elemental Landscape: Cairn at Dogwood Acres Drive

Condition: Hairline fracture in top rock

Maintenance / Treatment Rec.: "All repairs or replacement must be approved by Artists." For specifics, see "Art Maintenance Requirements" PDF on file

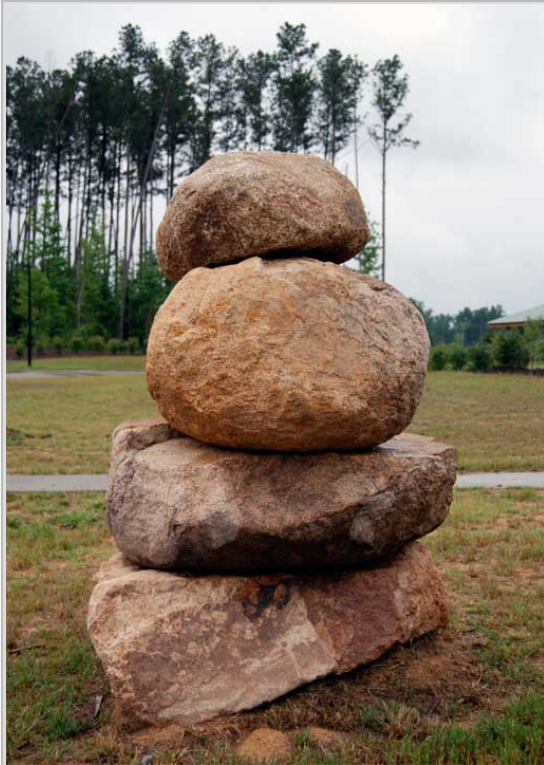
Elemental Landscape: Cairn, Central

Condition: OK - SBW

Earlier Reports: 02/17/2012 - top boulder put back on top some weeks ago, secured w/ some adhesive (epoxy?) by Landscaping
10/4/2011 - Robert Minick will have crew place boulder back on cairn

Maintenance / Treatment Rec.: "All repairs or replacement must be approved by Artists." For specifics, see "Art Maintenance Requirements" PDF on file

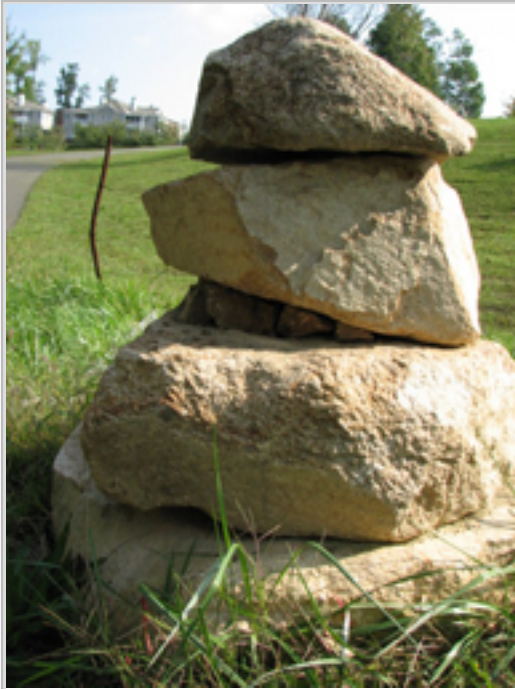
Elemental Landscape: Cairn at Scroggs Elementary

Condition: OK - SBW

Maintenance / Treatment Rec.: "All repairs or replacement must be approved by Artists." For specifics, see "Art Maintenance Requirements" PDF on file

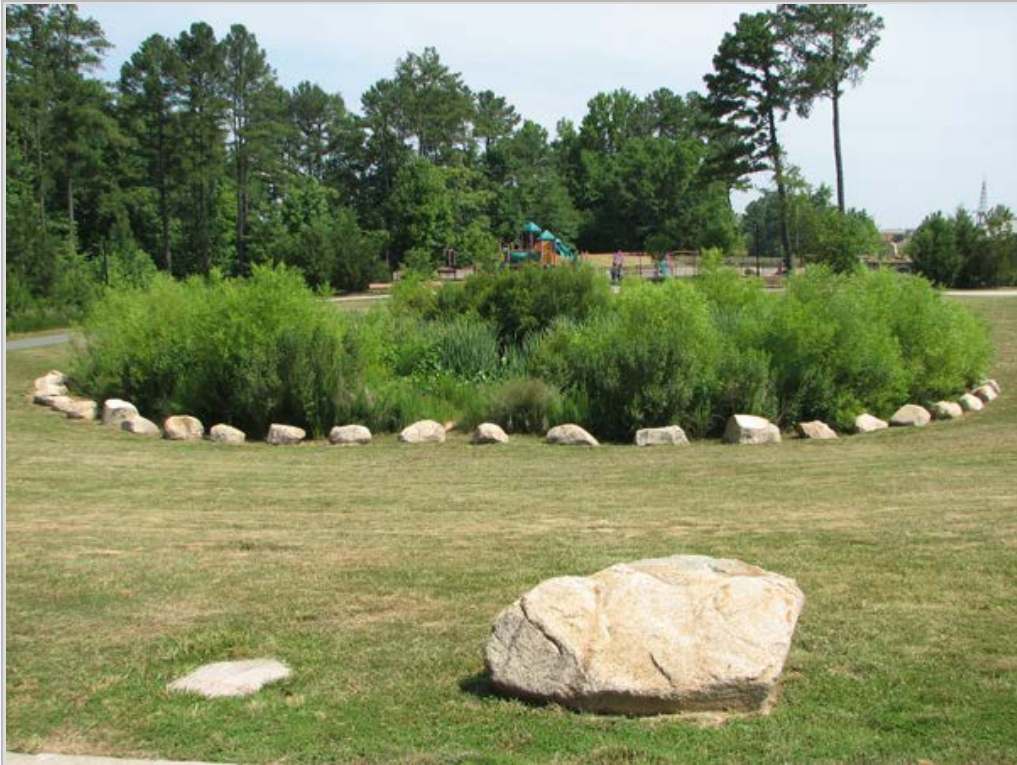
Elemental Landscape: Water

Condition: vegetation seems mature, full, and looks great

Maintenance / Treatment Rec.:
2/17/2012, 3/8/2011 - Weedy, cattails still present
4/9/2010 - Cattails will be removed accding to P&R.
9/25/09 - 3 inner circle boulders were moved, landscaping reset
"All repairs or replacement must be approved by Artists." For specifics, see "Art Maintenance Requirements" PDF on file

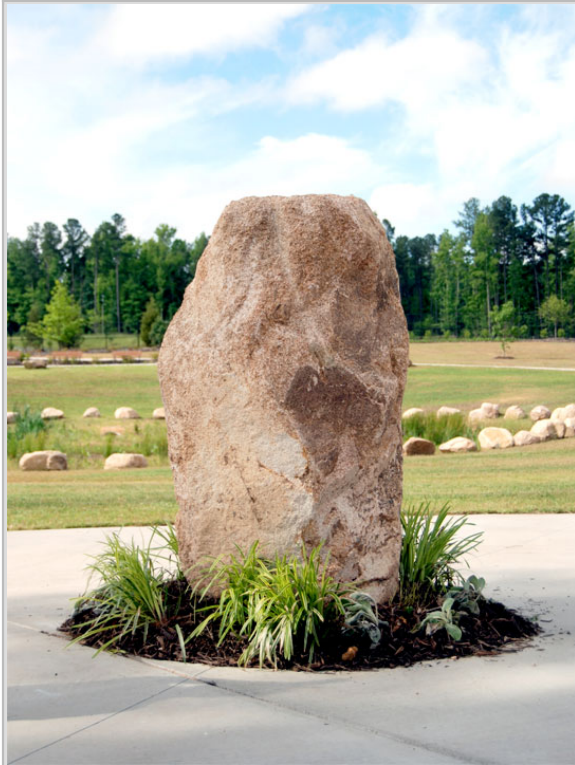
Elemental Landscape: Goddess Rock

Condition: good. Plantings are good. -SBW

Earlier Reports: 02/17/2012, 3/30/2011 - 80% of plantings at base haggard / dead 4/9/2010 - OK - SBW

Maintenance / Treatment Rec.: "All repairs or replacement must be approved by Artists." For specifics, see "Art Maintenance Requirements" PDF on file

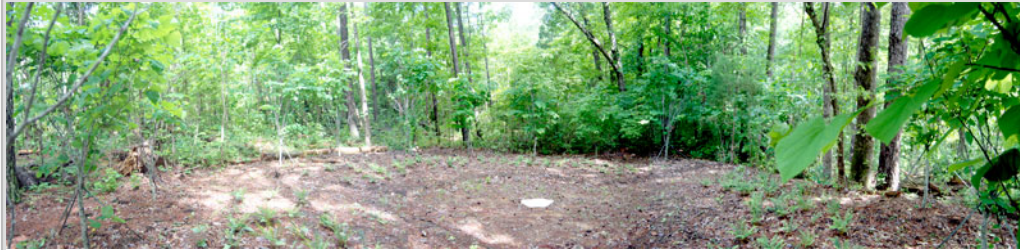
Elemental Landscape: Flora

Environmental Factors: Site reverting to nature, almost indistinguishable. Baby pines, other plants infiltrating. Planted Trillium, Bugelweed, ferns scarce

Earlier Reports: 2-17-2012 - Ferns, Trillium & Bugelweed scarce.
10/4/2011 - insp. w/ R. Minick & J. York. ferns are in fair condition. Trillium & Bugelweed scarce. Redbuds OK except 1 tree completely

Maintenance / Treatment Rec.: "All repairs or replacement must be approved by Artists." For specifics, see "Art Maintenance Requirements" PDF on file

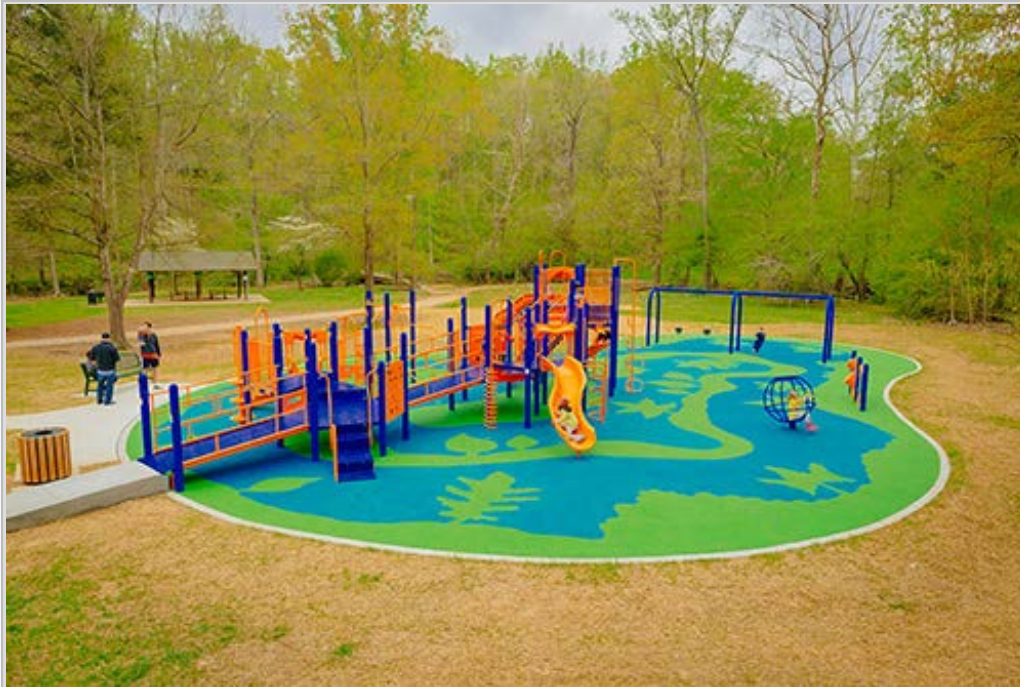
Umstead Park Play Surface

Condition: good
